Cavity Walls

Advantages and disadvantages of Cavity Walls

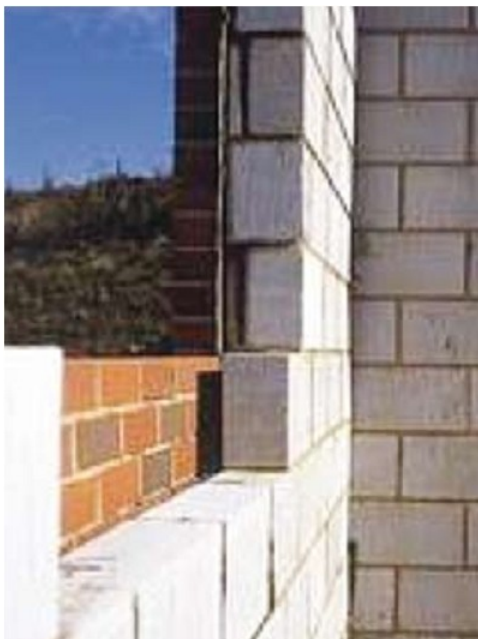
Fig1—Modern brick/block cavity wall

Cavity wall construction consists of outer and inner "leaves" (thin walls approximately 100mm thick) of brick and concrete block respectively, tied together with steel wall ties with a 50- 90mm cavity between them (see Figs 1 & 2). It became common practice in the house building boom of 1920 - 30 and since World War II it has been used almost universally.

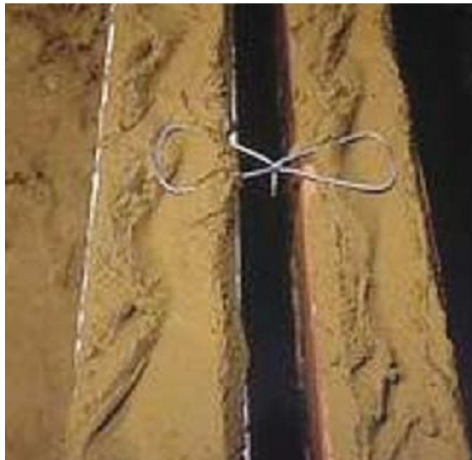
Fig2—Wall tie installation

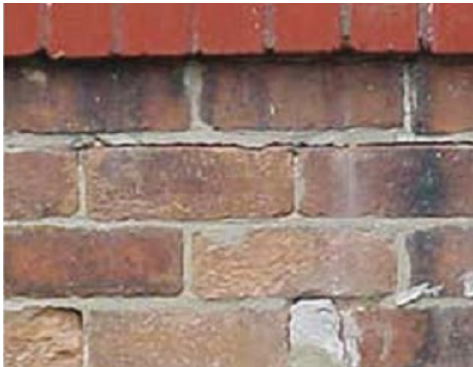
Fig4—Horizontal cracking in mortar joint

The main cause of deterioration of cavity walls is wall tie corrosion. If inadequately protected, the steel ties will rust due to the presence of air and water in the cavity. The constituents of mortar droppings can accelerate this process. When steel corrodes it will expand up to ten times the thickness of the parent metal. The ends of the wall ties embedded in the outer leaf will lift the bricks above, causing a horizontal crack to appear in the mortar joint (see Fig 4).

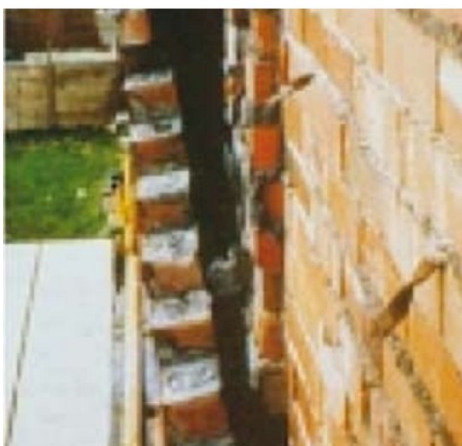
Fig5—Separation of outer leaf

In extreme cases, the outer leaf can become separated from the inner leaf and fall off (see Fig 5). however, it must be stressed that this very rarely leads to any further collapse of the wall, and so there is no immediate threat to the safety of the occupants of the property.
